**VINCE MEURLOTT P.E.
ENGINEERING AND INSPECTIONS**

Job: 330 Barnette FINAL Building Evaluation for Purchase Report May 2022

Seth-De-Ya-Ah Corporation
615 Bidwill Avenue, Suite 405
Fairbanks, AK 99701

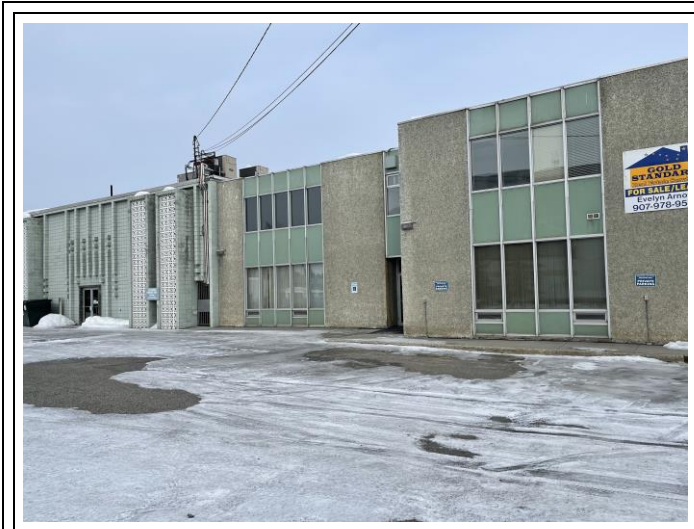
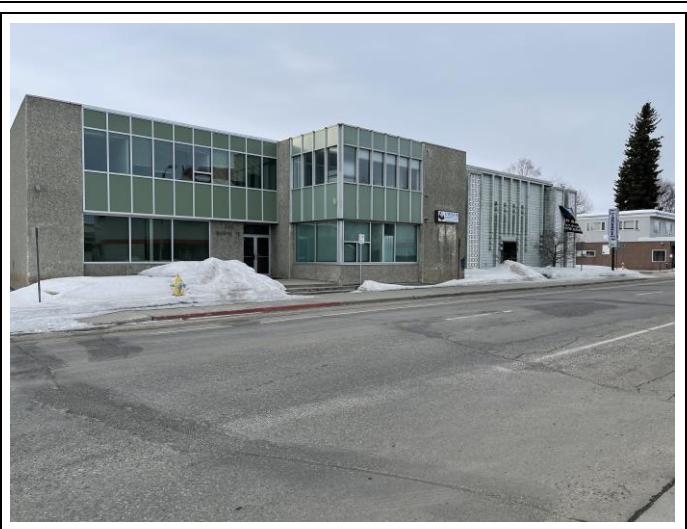
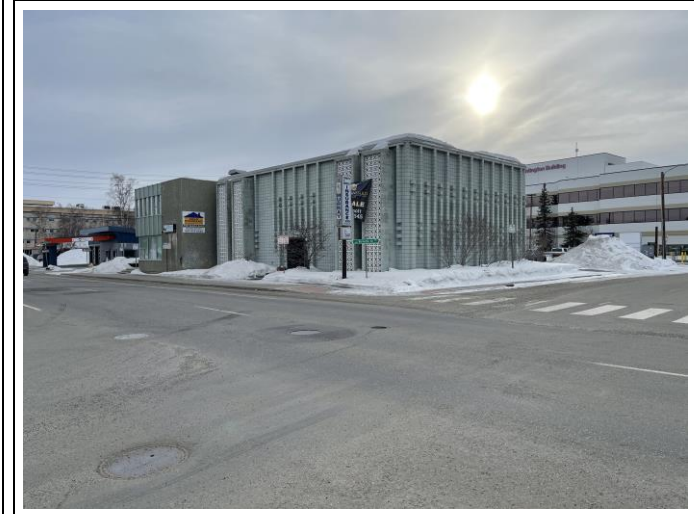
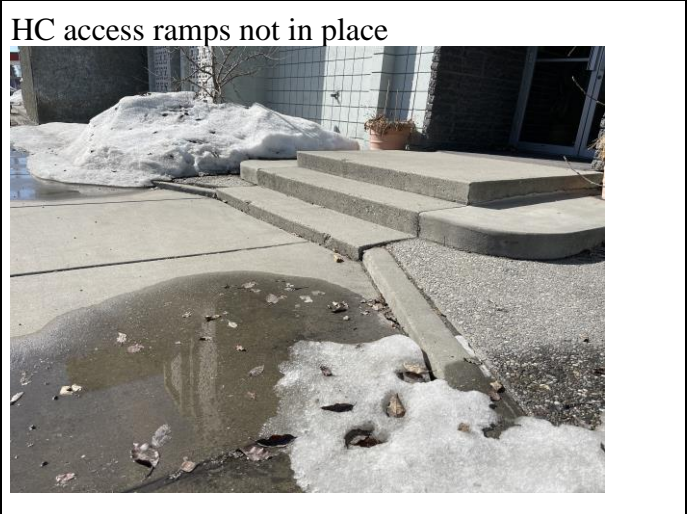
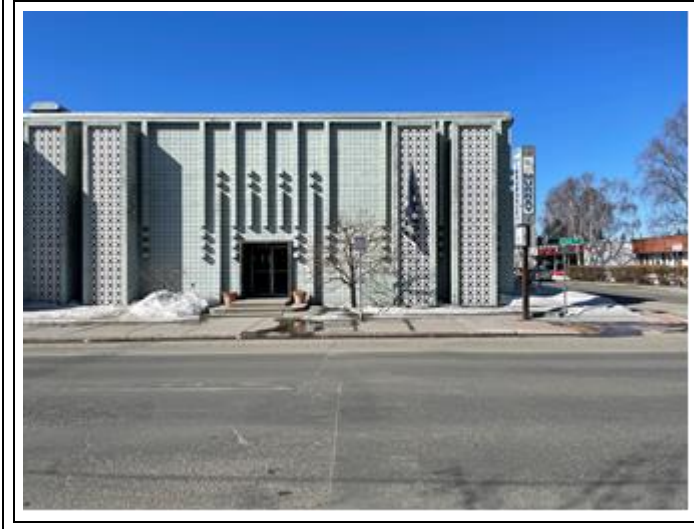
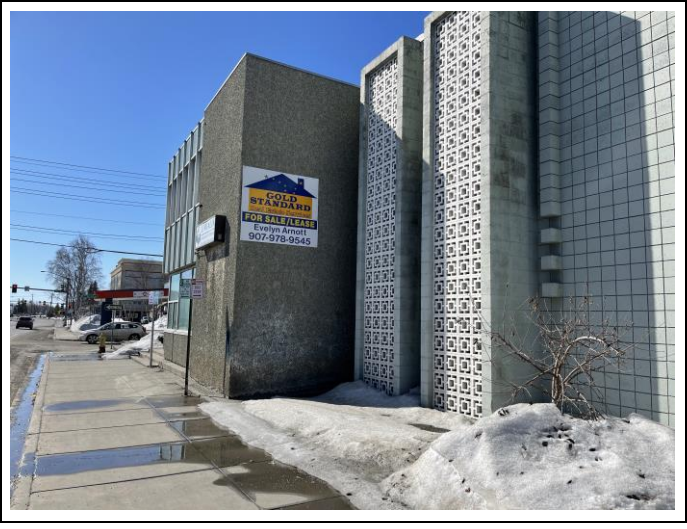
Exterior surfaces are in good condition.

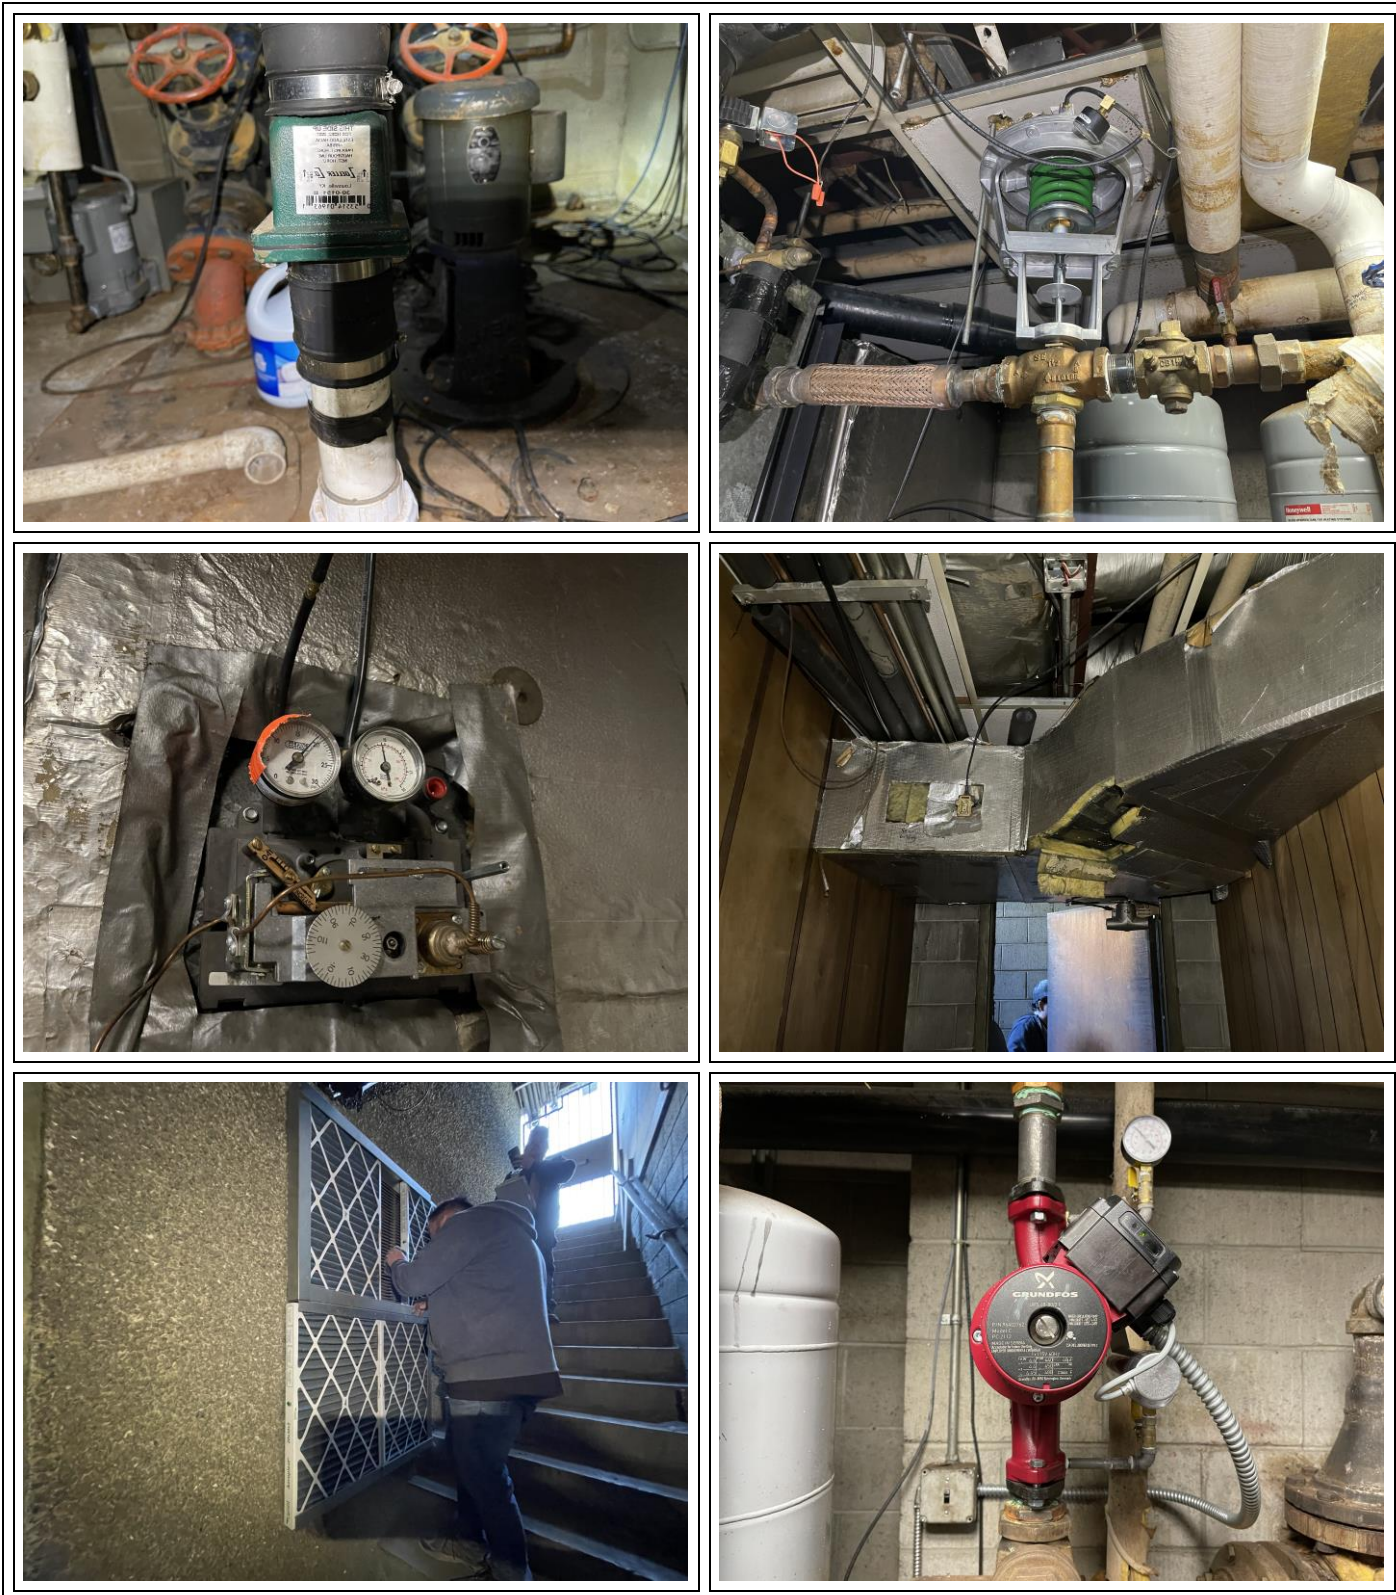
Most equipment is old but functional. Filters need changing. There are a few new pumps

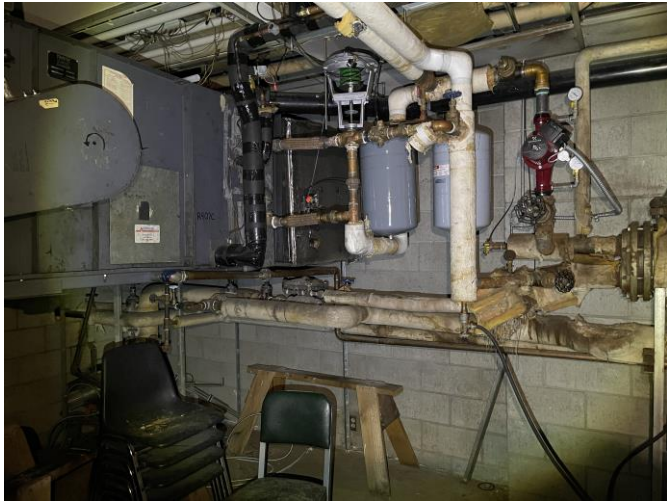
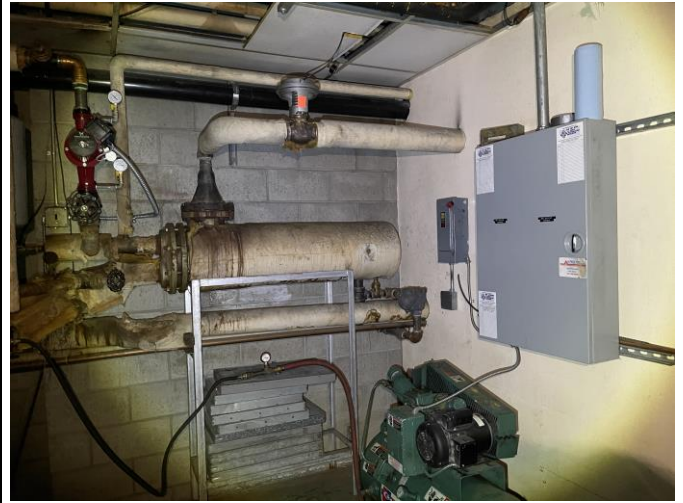
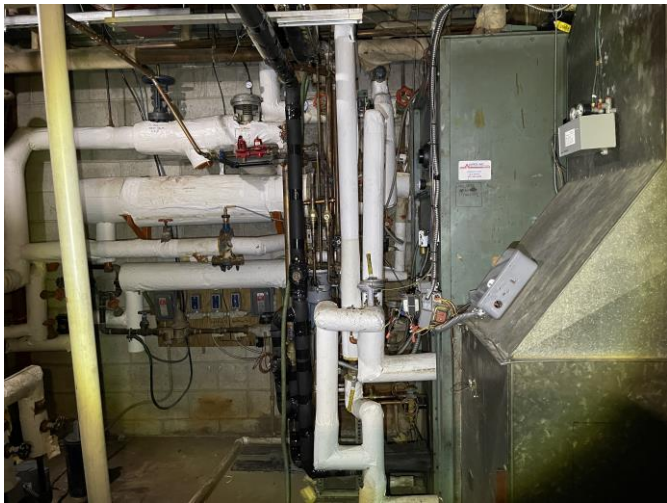
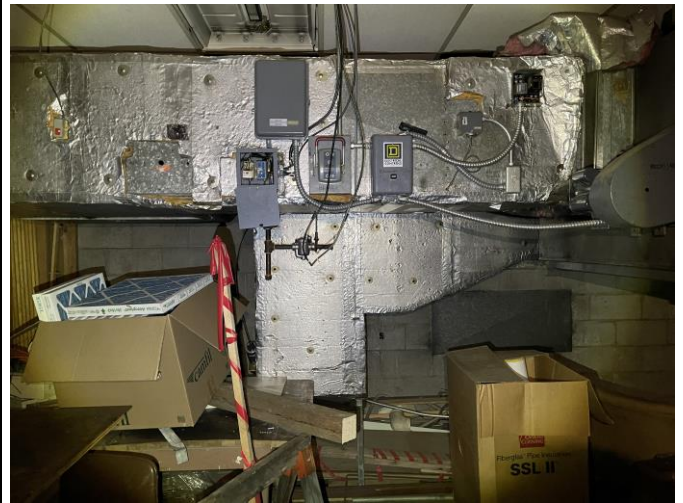
Insulation on pipes appears to be only fiberglass not asbestos.

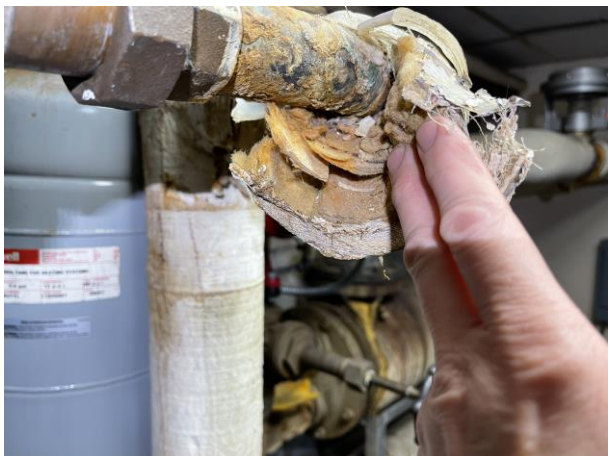
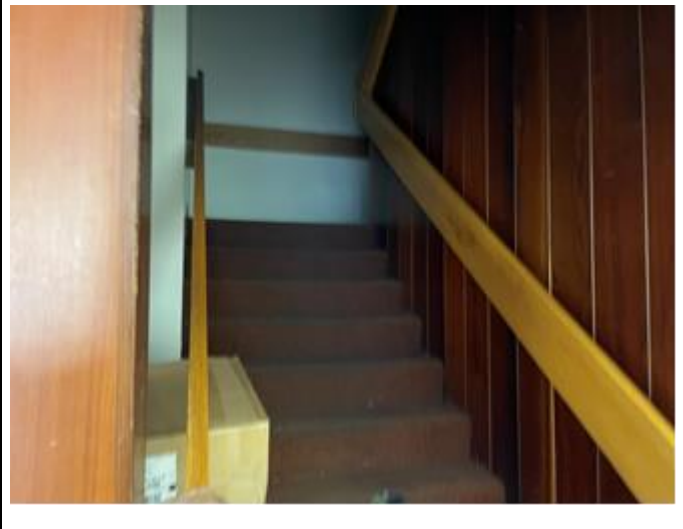
- No large problems noted.
- Some guardrails have plexiglass installed to eliminate the large spaces between the balusters. The plexiglass should be installed on all guardrails to comply with the newer codes that mandate that a 4" ball is not able to pass on guards except a 6" ball at the corner of riser and tread on stairs for safety.
- Windows within 24" of doors are to be safety glazing or tempered per the Building Code. Some were noted in the unoccupied second level South side suite.

Install plexiglass or similar to reduce gaps

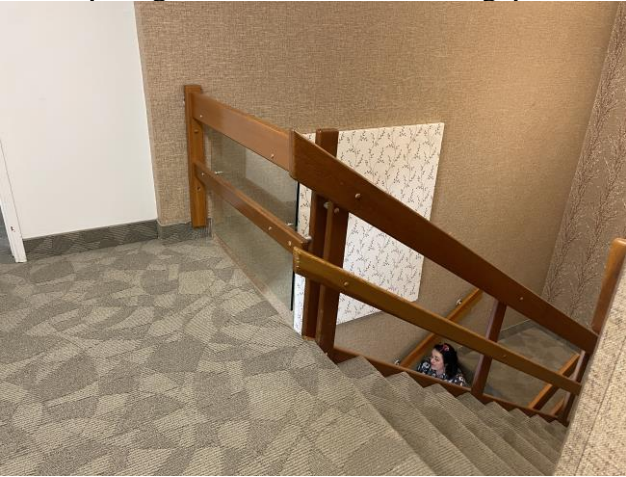
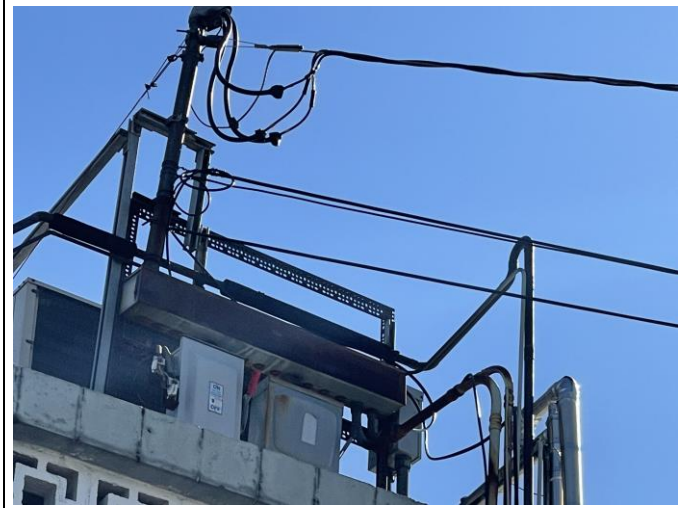
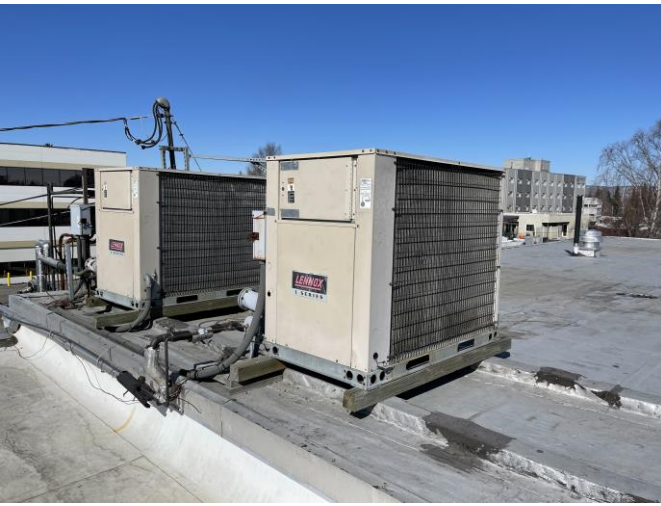
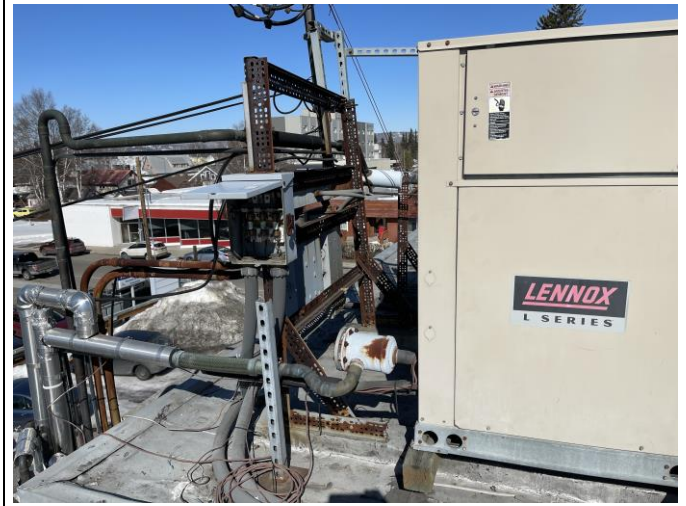
See report Interior A & K electric attached. It lists normal corrections such as need for labeling, covers and maintenance or replacement of emergency lighting. Improvements to grounding are recommended as well but are not code mandated. I noted old fuse type disconnects for some equipment on the roof. Newer circuit breakers are recommended for ease of use. Wires above the suspended ceiling should be supported every 4' or less.

Panels on roof could be cleaned up for neatness. Fuses could be replaced with circuit breakers.

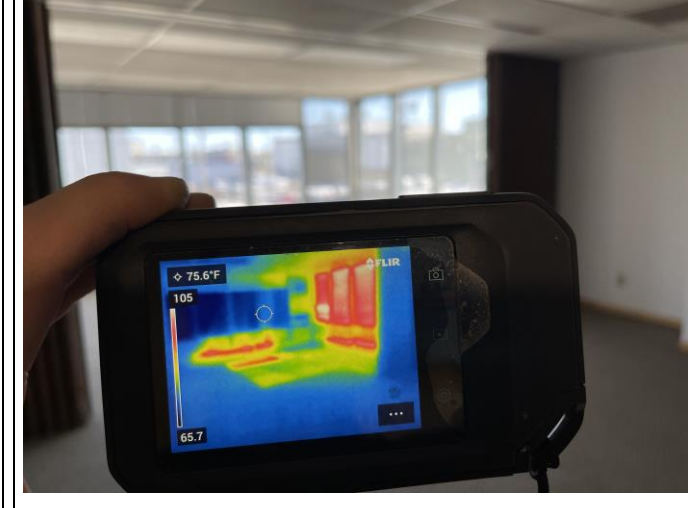
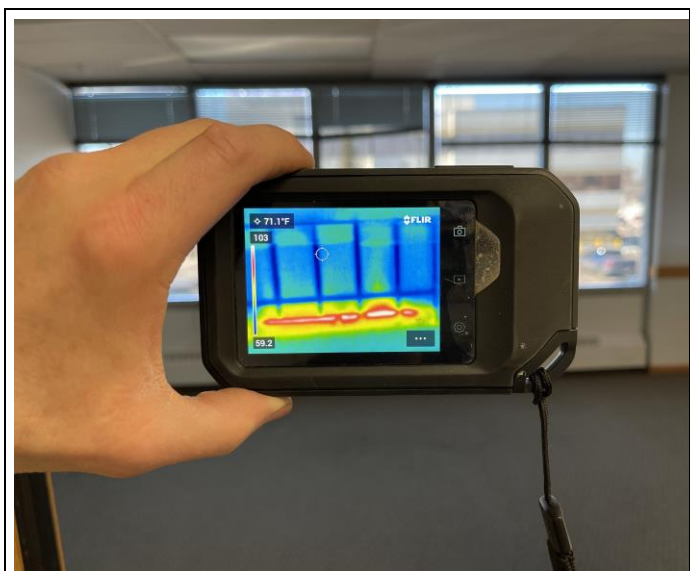
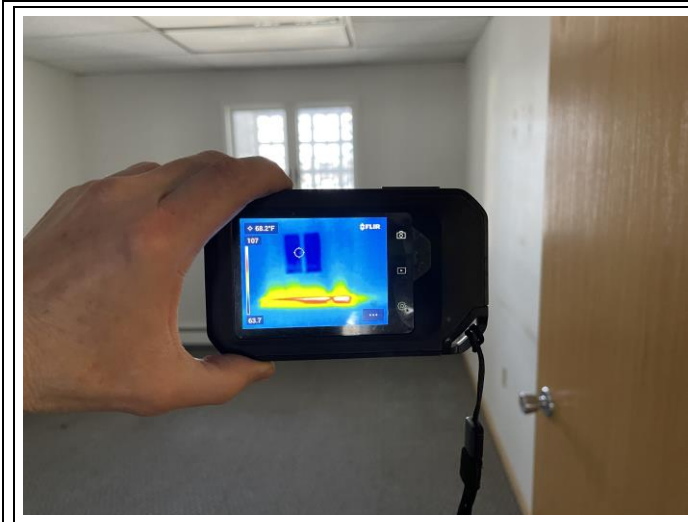
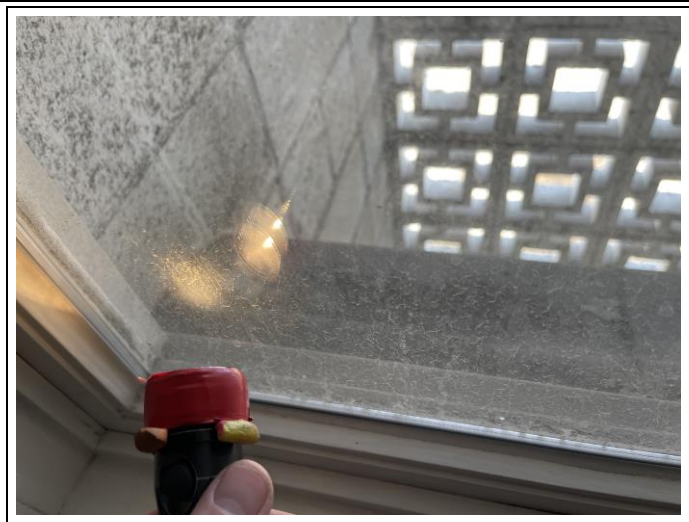
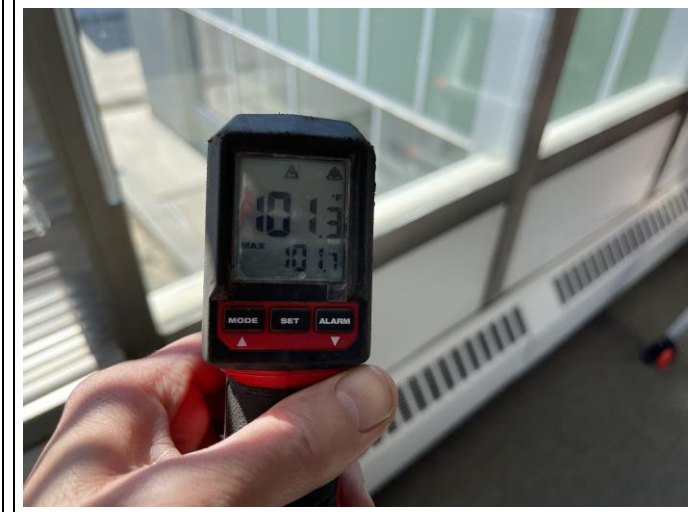
Large solar gain on south facing windows

CMU block outside the exterior walls as a façade (shown above) helps reduce solar gain but other locations (shown to the left) with south face have large solar gain.

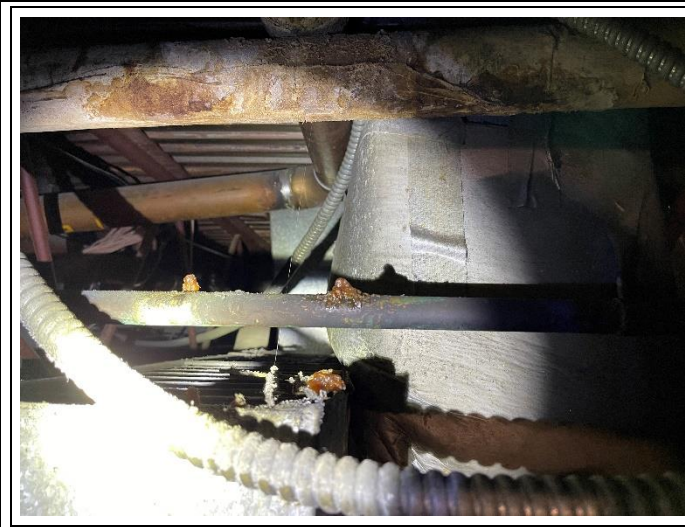
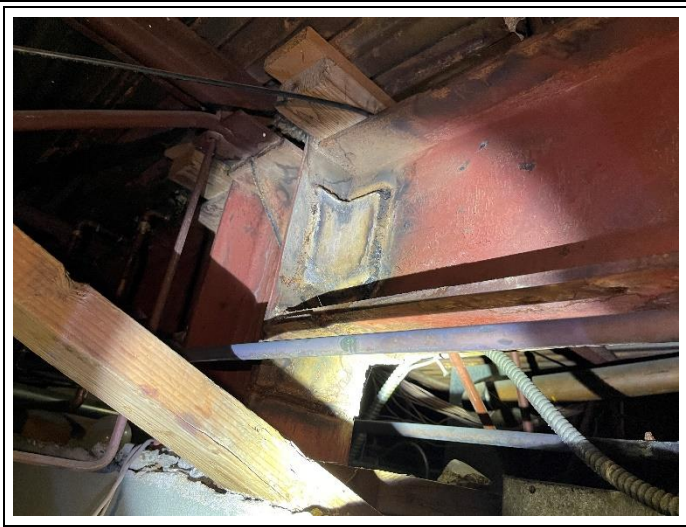
Mechanical and structural items in the way of a elevator installation on the south side hall.

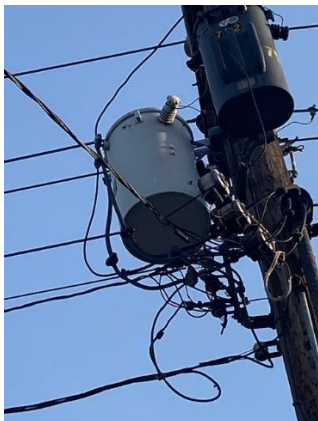
Pic 1

1- The service equipment may require revision in the future. It is functional but not to current GVEA requirements. There appear to be two separate services to the building. See pics 1&2. NEC 230.72 requires the service disconnects be grouped together. This is not the case as shown in the aforementioned pictures. The facility is currently non-compliant, as one disconnect is on the roof and the other is in the MDP in the basement. **NEC 230.2(E) requires identification placards noting the location of any other allowable disconnecting means.** Generally the City of Fairbanks and GVEA do not require improvements unless they are quite dangerous so improvement is up to you.

Service-drop to roof disconnect.

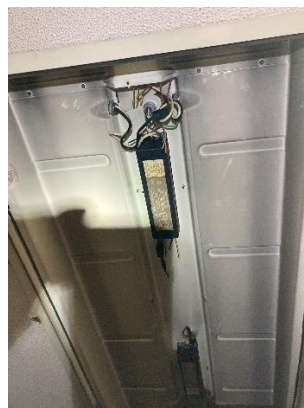
Pic 10

7- Fixture was missing lens and ballast channel (pic 10).
