Date of Initial Inspection: August 11, 2022

Job: 425 Baranof August 11, 2022

This engineer's report was prepared for you after my inspection with Noah Goslin assisting. For brevity positive merits of the building are not reported here. Disclosures were not provided. Recommendations for correction are listed with some suggestions for future reference following:

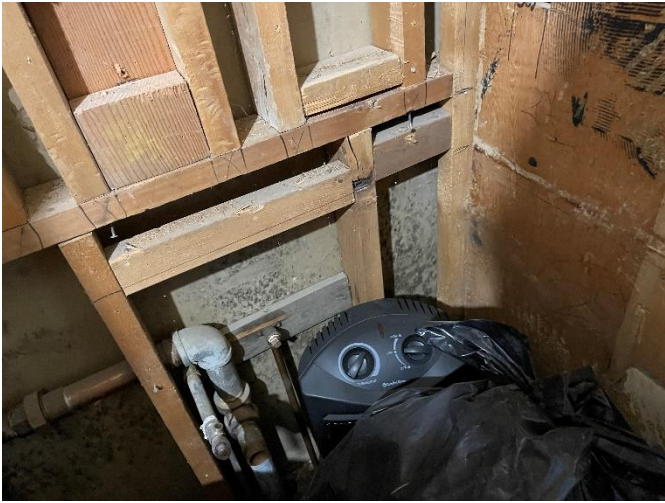
Replace the inexpensive Oatey brand air admittance valve with a Studor type

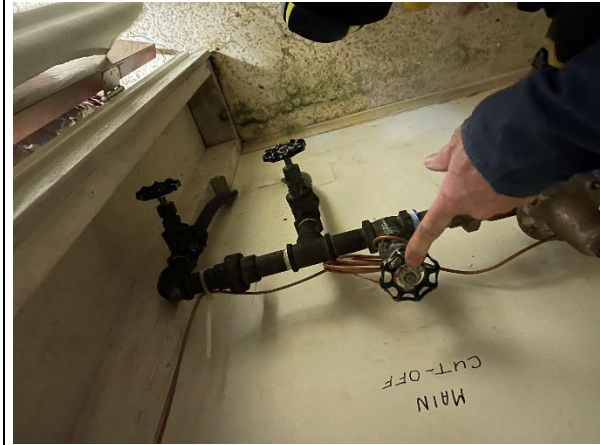
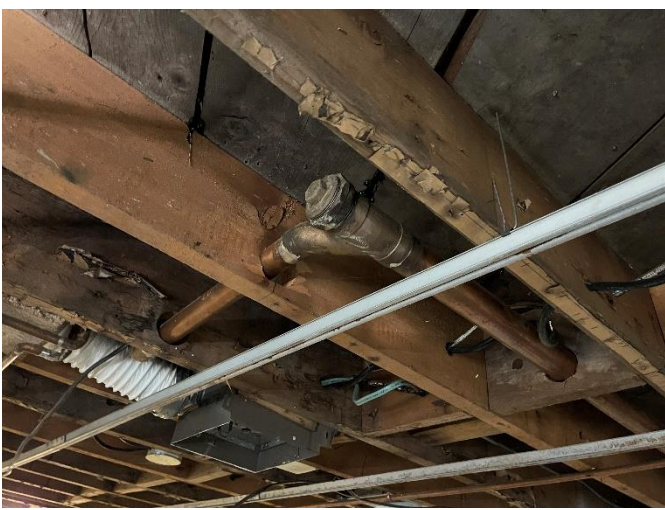
Leave access to the plumbing clean out above the ceiling.
