**VINCE MEURLOTT P.E.  
ENGINEERING AND INSPECTIONS**

Date of Initial Inspection: February 13, 2022

Job: 505 W. 2nd St Anchorage Grand Hotel Commercial Building Evaluation Feb 2022

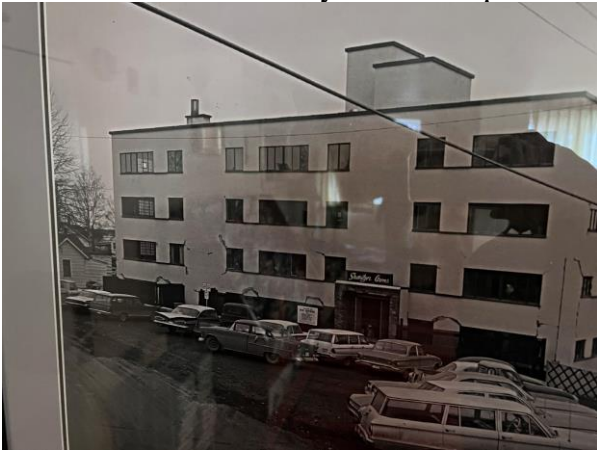
- n. A photo of the hotel in the lobby after the big 1964 earthquake appears to show minimal damage from my perspective.
- o. I requested records of the Municipality of Anchorage Fire Department. They are attached. No significant building construction concerns were raised - **but maintenance problems have been noted with regard to door stops and needed signage to alert occupants or tenants that fire doors are to be kept closed. See attached notices.**

Historical Photo in Lobby after earthquake

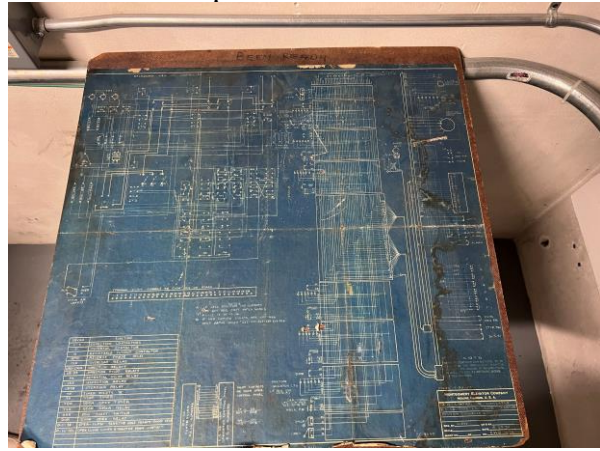
Old "blue line" print mounted on board

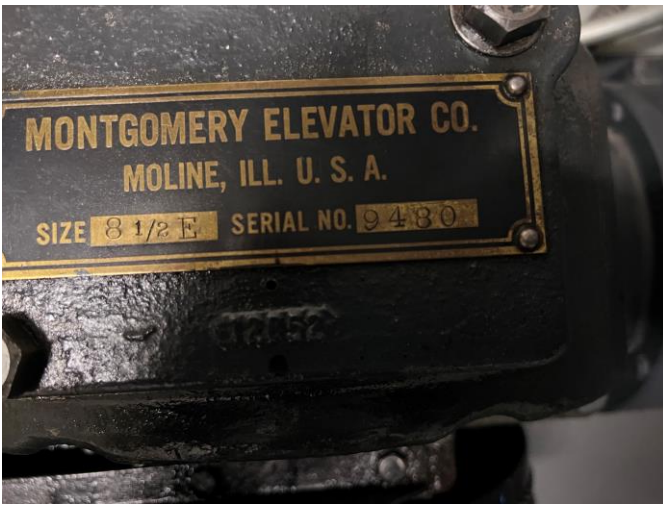
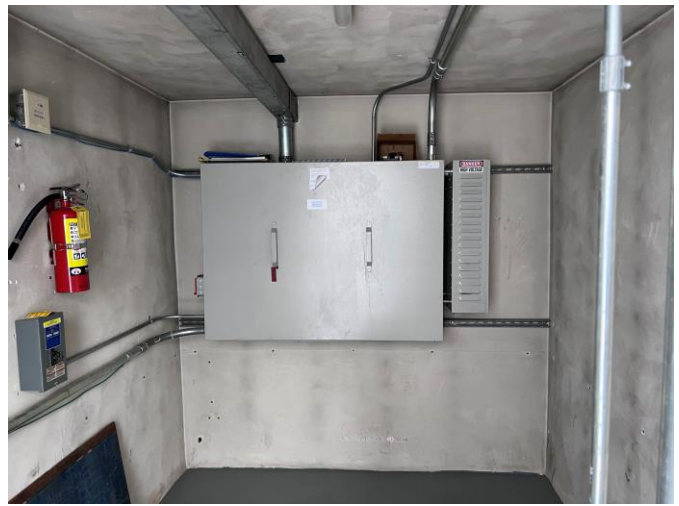
- b. Elevator equipment appeared to be old but in good condition.
- c. Roof drains appeared to be clear and functional.
- d. We checked several of the electrical panels. They appeared to properly wired and labeled.

MONTGOMERY ELEVATOR CO.  
MOLINE, ILL. U. S. A.  
SIZE 8 1/2 E SERIAL NO. 9480

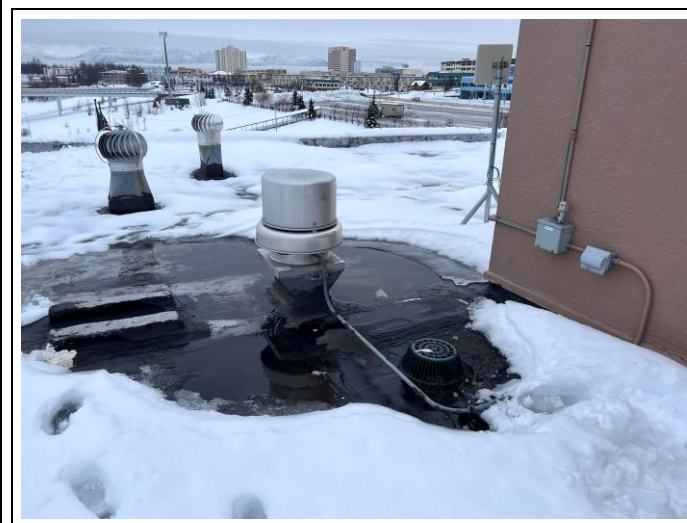
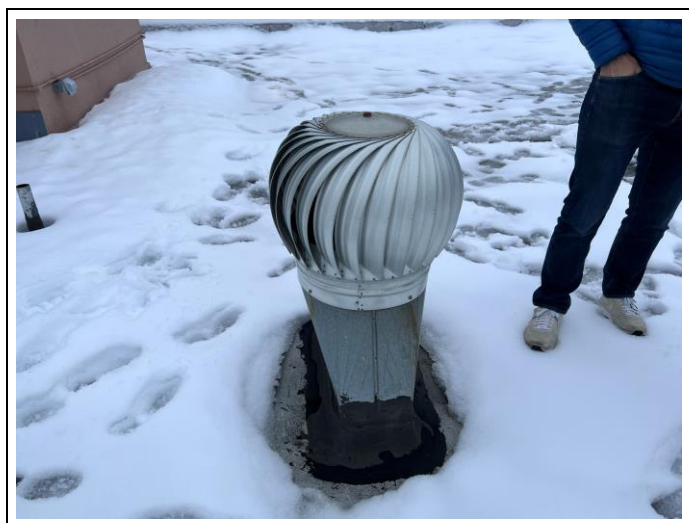
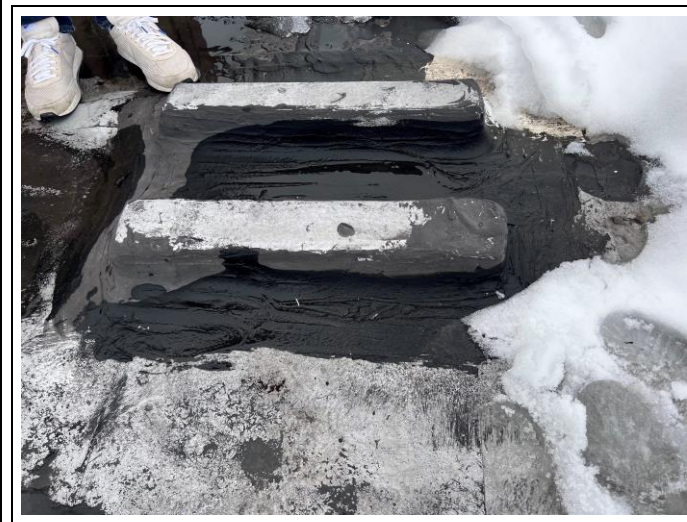
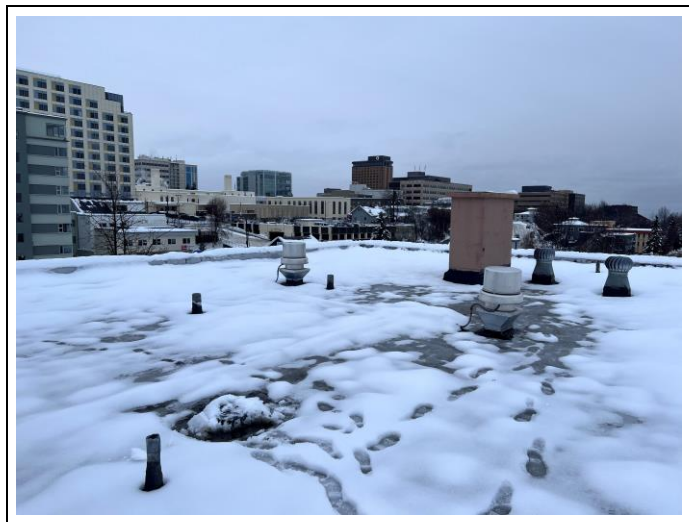
7. Have a licensed contractor evaluate the roof membrane for estimated useful life remaining and cost to replace. Some snow removal would be required. We exposed a little of the roofing. It appeared to be membrane type which is desirable but appeared to have many "mop on" type patches. We only noted one area of the ceiling that had moisture damage which was acknowledged by the seller.

Elevator room above shaft. Membrane roof covering with turbine vents

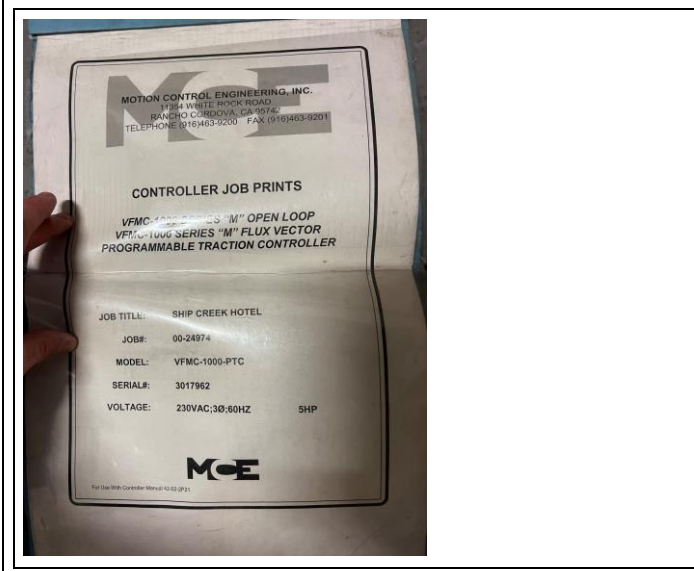
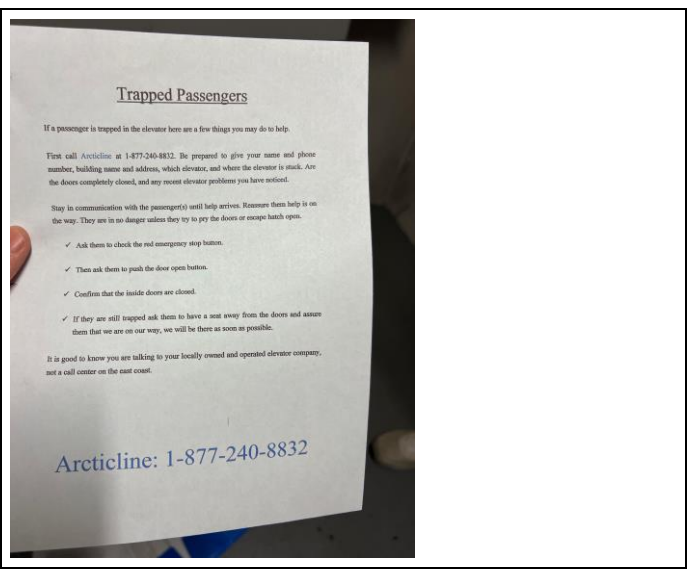
Chinook Fire Protection tags found along with some equipment manuals and elevator use directions.

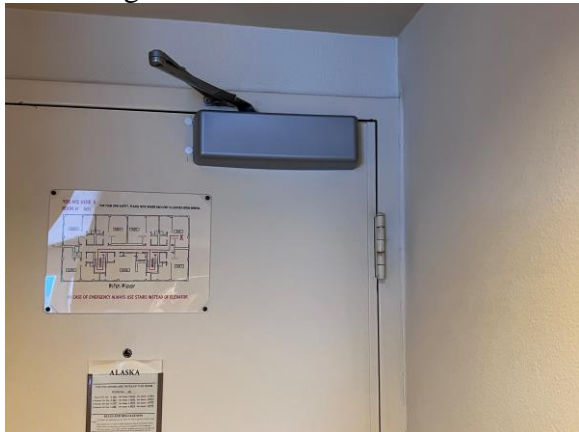
Door closers to hall appear to work well. Signage for exiting on inside of door.

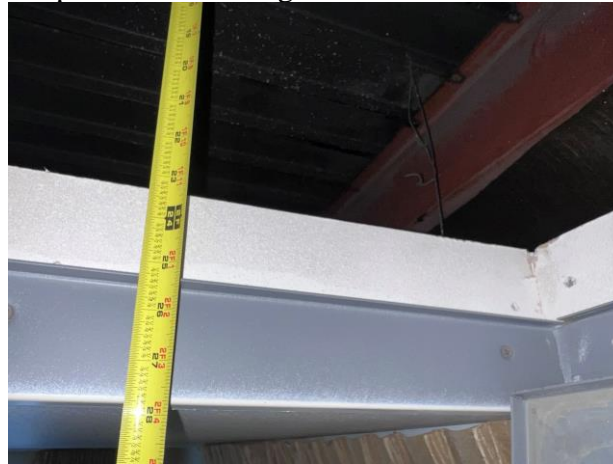
- l. You may be able to add insulation above the ceiling on the top level. There is 2' between the ceiling and bottom of the roof.
- m. I requested records of the Municipality of Anchorage Building Department. They were reluctant to provide the historical records earlier than the year 2000. I believe those are still in paper and would take a lot of effort to procure. Only one notable "deficiency" was permit #F00-4039 for the sprinkler system that was not closed out. A current inspection and approval requested above should properly address that. The newer permit for a change in use from a hotel to apartments submitted by Architect Daniel Clift is still in process as the work has not been completed or inspected which is expected.

2' space above ceiling to underside of roof deck

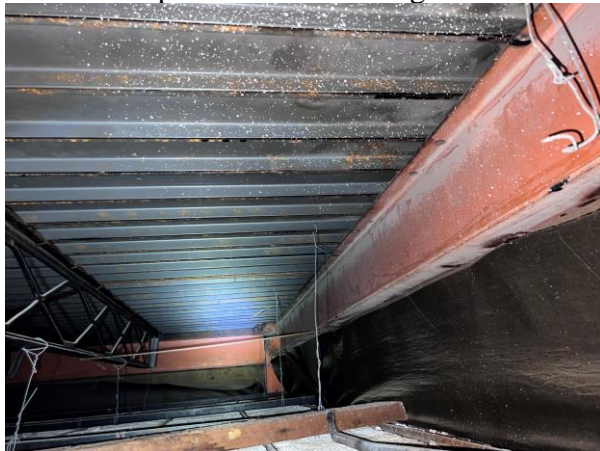
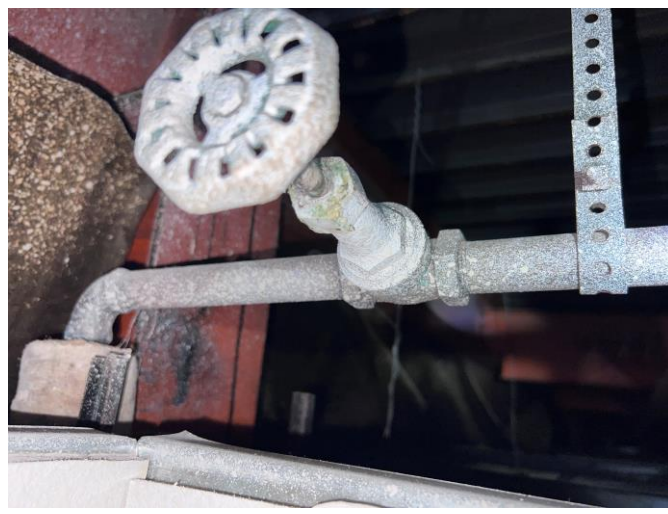
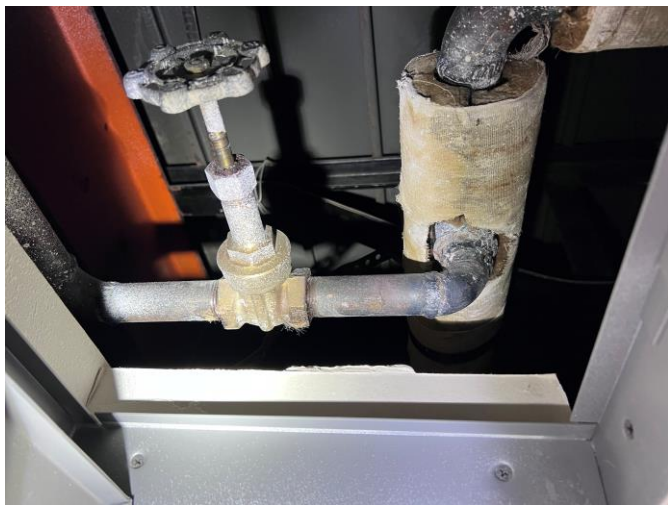
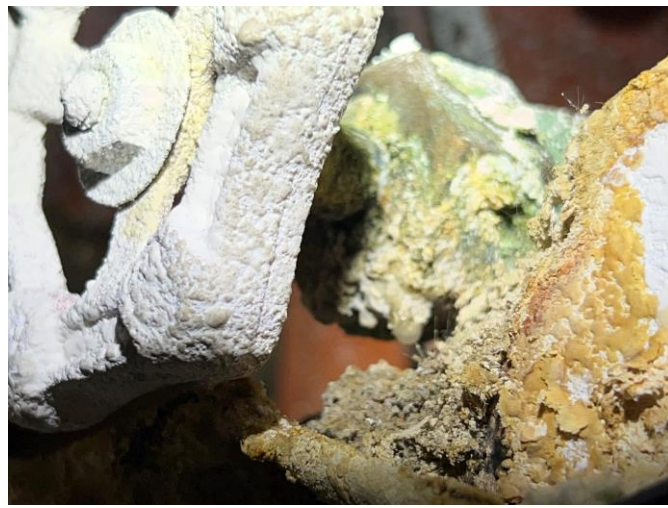
Interstitial space between ceiling and roof.

Leak at one location above the top level ceiling and roof deck.

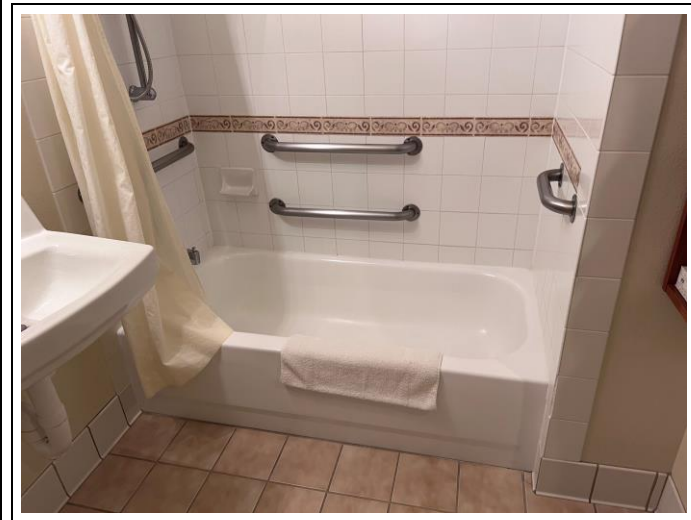
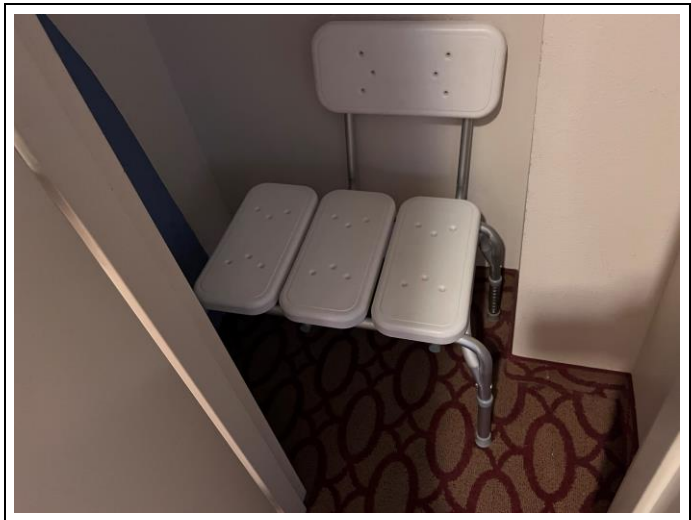
- p. We note some accessible units with grab bars, lower sinks and under sink clearance.
- q. We note nice newer “smart” pumps for the hydronic system and a bypass cylinder to flush out sediment in the hydronic fluid.

Typical accessible unit bath

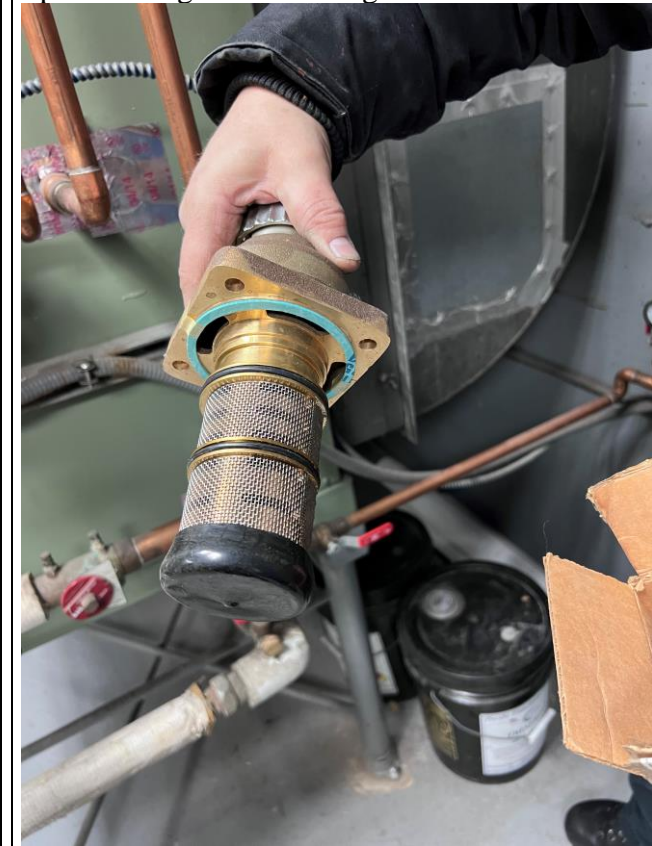
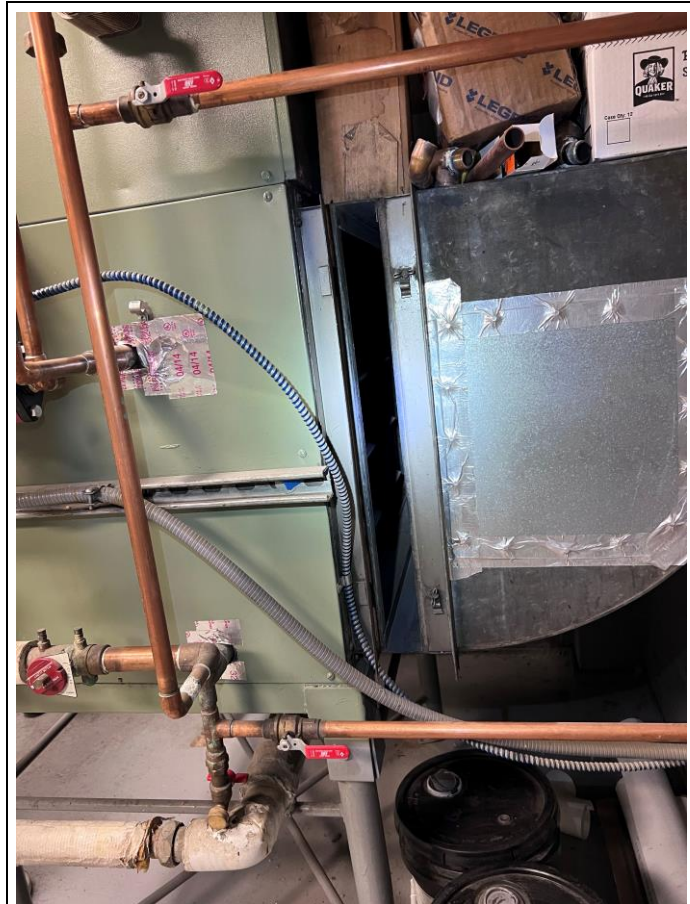
Exterior stair. CMU foundation wall is good. Nice expensive mixing valve in boiler room

Spare mixing valve cartridge

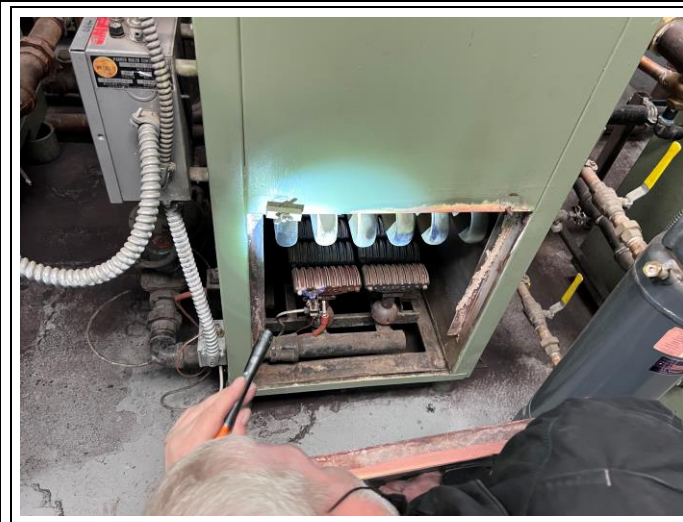
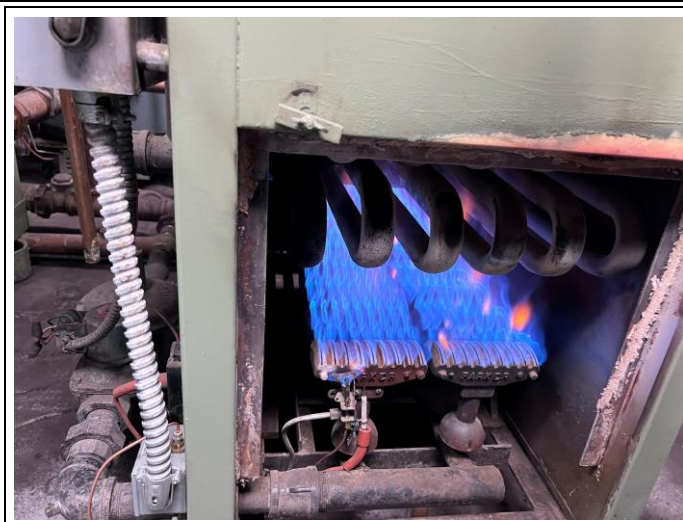
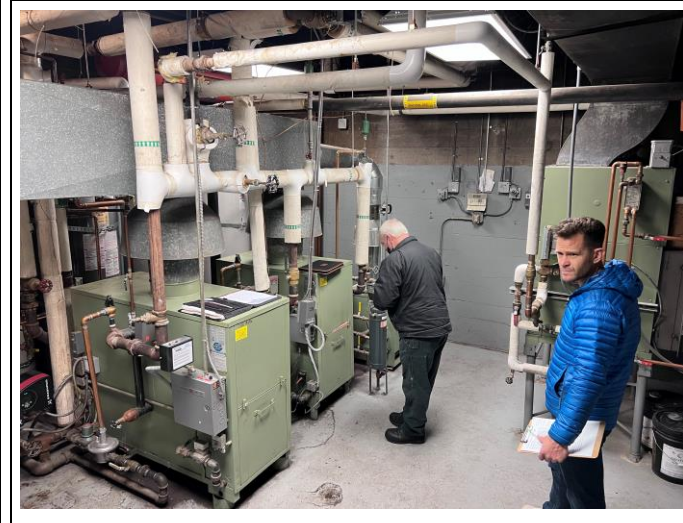
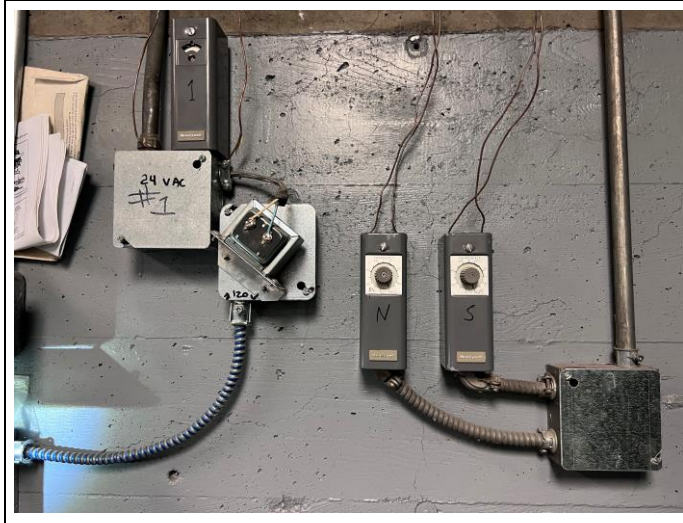
- a. The boilers and many of the controls for the older atmospheric type in place appear to work in an acceptable manner. It is best if they are replaced with newer ones that are energy efficient. We requested an evaluation of equipment and estimate to replace by a local mechanical contractor.

Boilers manufactured in 1970. Three used. Could replace with two.  
Two hot water makers use hot water from the boilers.  
One gas fired hot water gives quick delivery but might be replaced.

8. Have all three of the boilers inspected and fully serviced by a licensed and bonded contractor. Contractor is to check all safety items and perform necessary repairs. Ensure that the heat exchanger is cleaned. Supply a receipt to confirm the work. This is a normal service item that should be performed every year.
