Date of Initial Inspection: August 11, 2022

Job: 425 Baranof August 11, 2022

This engineer's report was prepared for you after my inspection with Noah Goslin assisting. For brevity positive merits of the building are not reported here. Disclosures were not provided. Recommendations for correction are listed with some suggestions for future reference following:

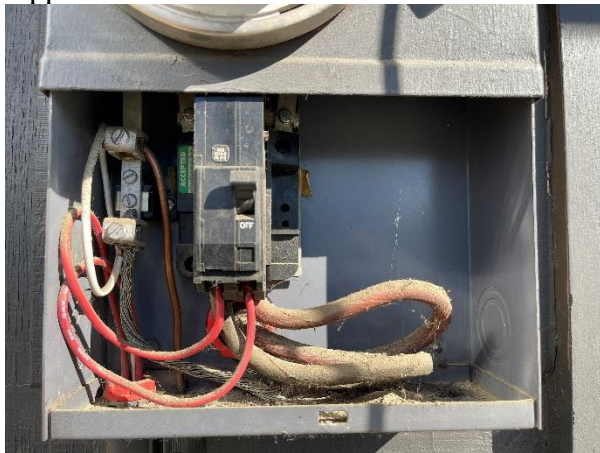
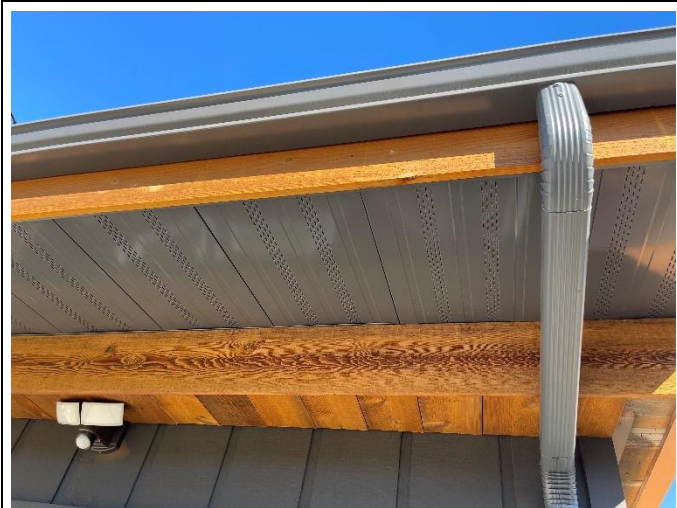
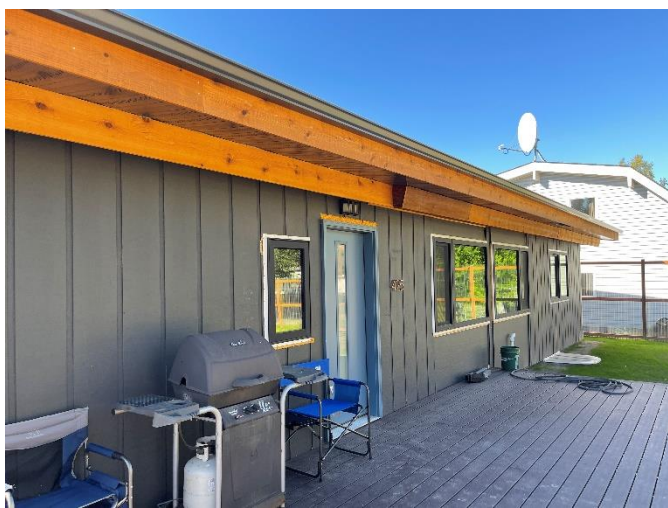
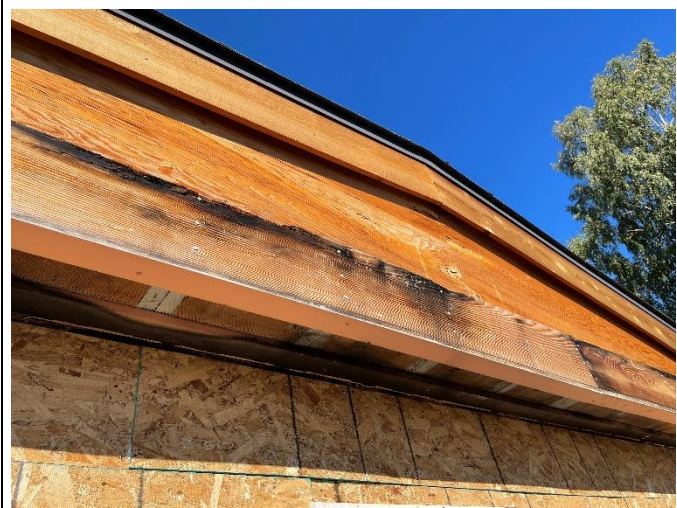
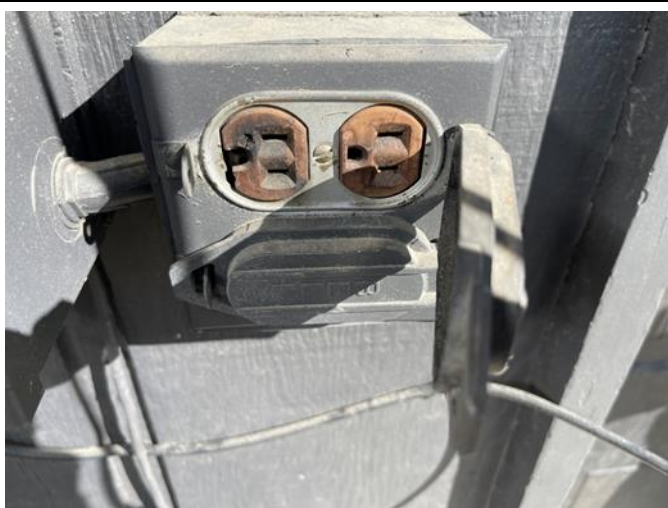
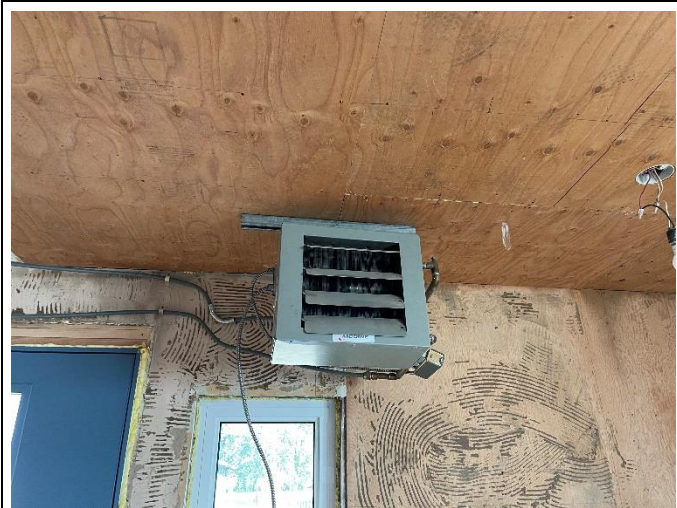
Reconfigure electrical service to eliminate double tapped electrical conductors

7. Reconfigure electrical service to eliminate double tapped electrical conductors.
8. Complete electrical work in garage.
9. Provide gfci protection for all garage receptacles except one that may be used for a freezer. Ensure the polarity and grounding are correct and the gfci protection will trip with an independent testing device.
10. Replace damaged exterior receptacle. Provide gfci protection for all exterior receptacles. Ensure the polarity and grounding are correct and the gfci protection will trip with an independent testing device.
11. Ensure that all circuit breakers in the panels are properly labeled. The label for each breaker should be numbered on the cover and correctly corresponds to the circuit referenced such that a user can quickly identify and disconnect power to the circuit.

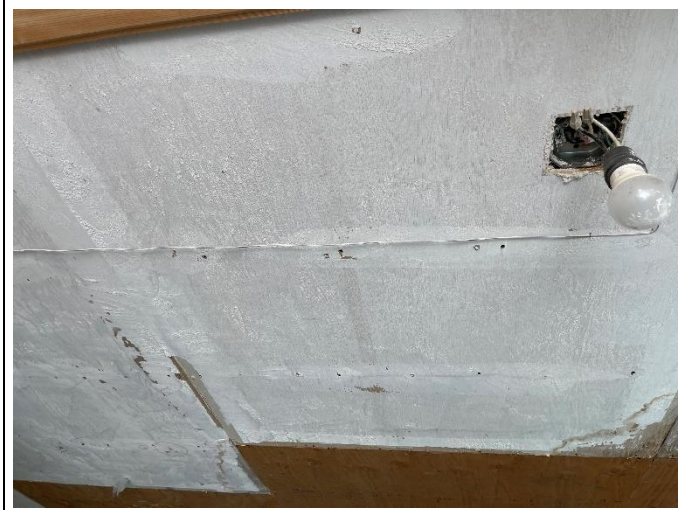
Leave access to the plumbing clean out above the ceiling.
