**VINCE MEURLOTT P.E.
ENGINEERING AND INSPECTIONS**

Job: 330 Barnette FINAL Building Evaluation for Purchase Report May 2022

Seth-De-Ya-Ah Corporation
615 Bidwill Avenue, Suite 405
Fairbanks, AK 99701

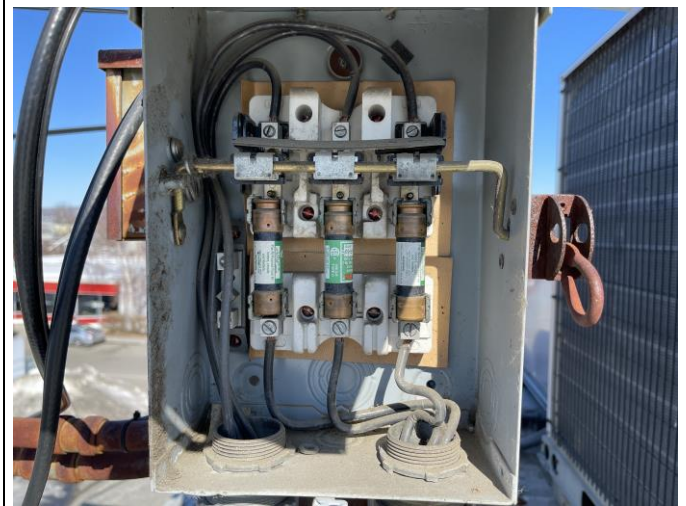
Panels on roof could be cleaned up for neatness. Fuses could be replaced with circuit breakers.

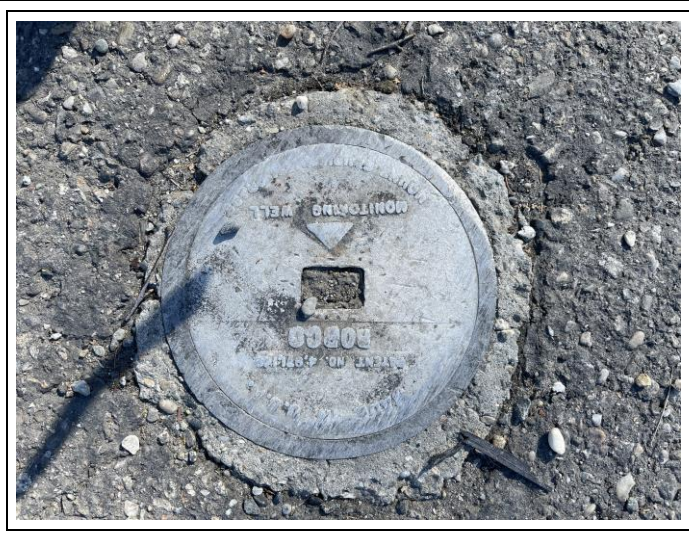
Photo below shows location of monitoring well.

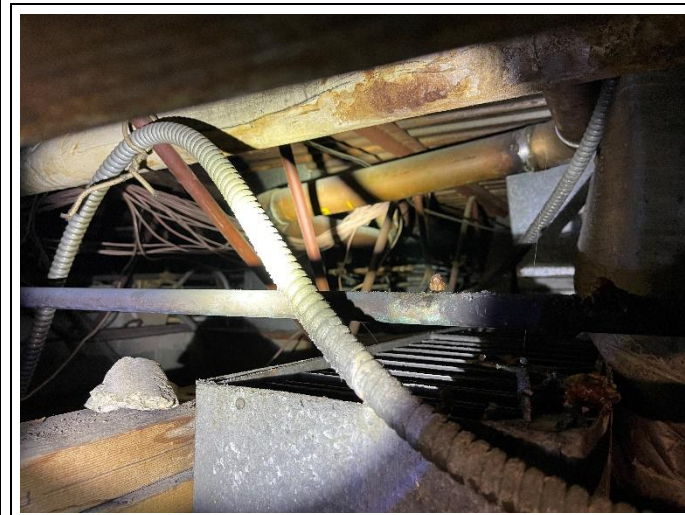
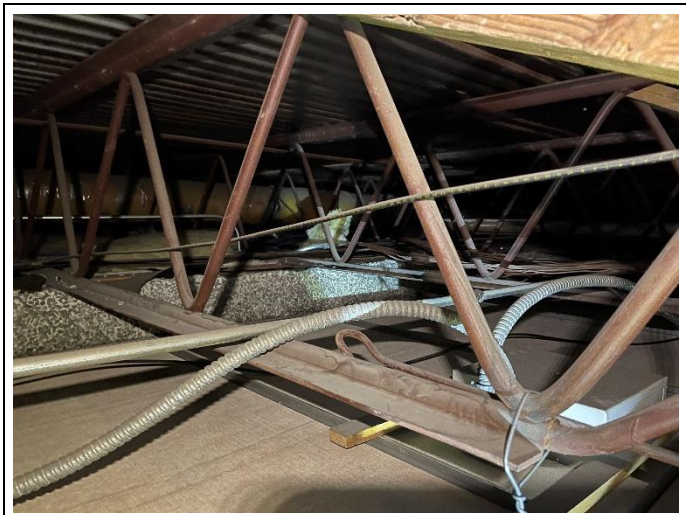
Mechanical and structural items in the way of a elevator installation on the south side hall.

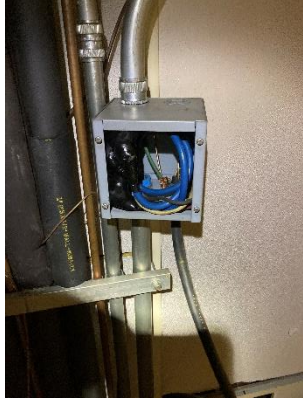
Pic 2

1- The service equipment may require revision in the future. It is functional but not to current GVEA requirements. There appear to be two separate services to the building. See pics 1&2. NEC 230.72 requires the service disconnects be grouped together. This is not the case as shown in the aforementioned pictures. The facility is currently non-compliant, as one disconnect is on the roof and the other is in the MDP in the basement. **NEC 230.2(E) requires identification placards noting the location of any other allowable disconnecting means.** Generally the City of Fairbanks and GVEA do not require improvements unless they are quite dangerous so improvement is up to you.

Underground service lateral to MDP in basement.

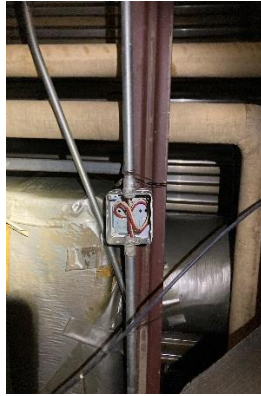
Pic 3

6- The mechanical equipment area has numerous code violations including but not limited to: missing or inadequate labeling (pic 6 & 8), lack of junction box covers on boxes (pics 3-8), improper strain relief (pic 6), lack of equipment covers, exposing energized parts (pic 6), and lack of proper box and conduit supports (pic 4). All are NEC violations.
